Installation Restoration Program

Final Report Phase II, Stage 1 - Problem Confirmation Study Norton Air Force Base San Bernardino, California

Volume I - Technical Report

July 1985

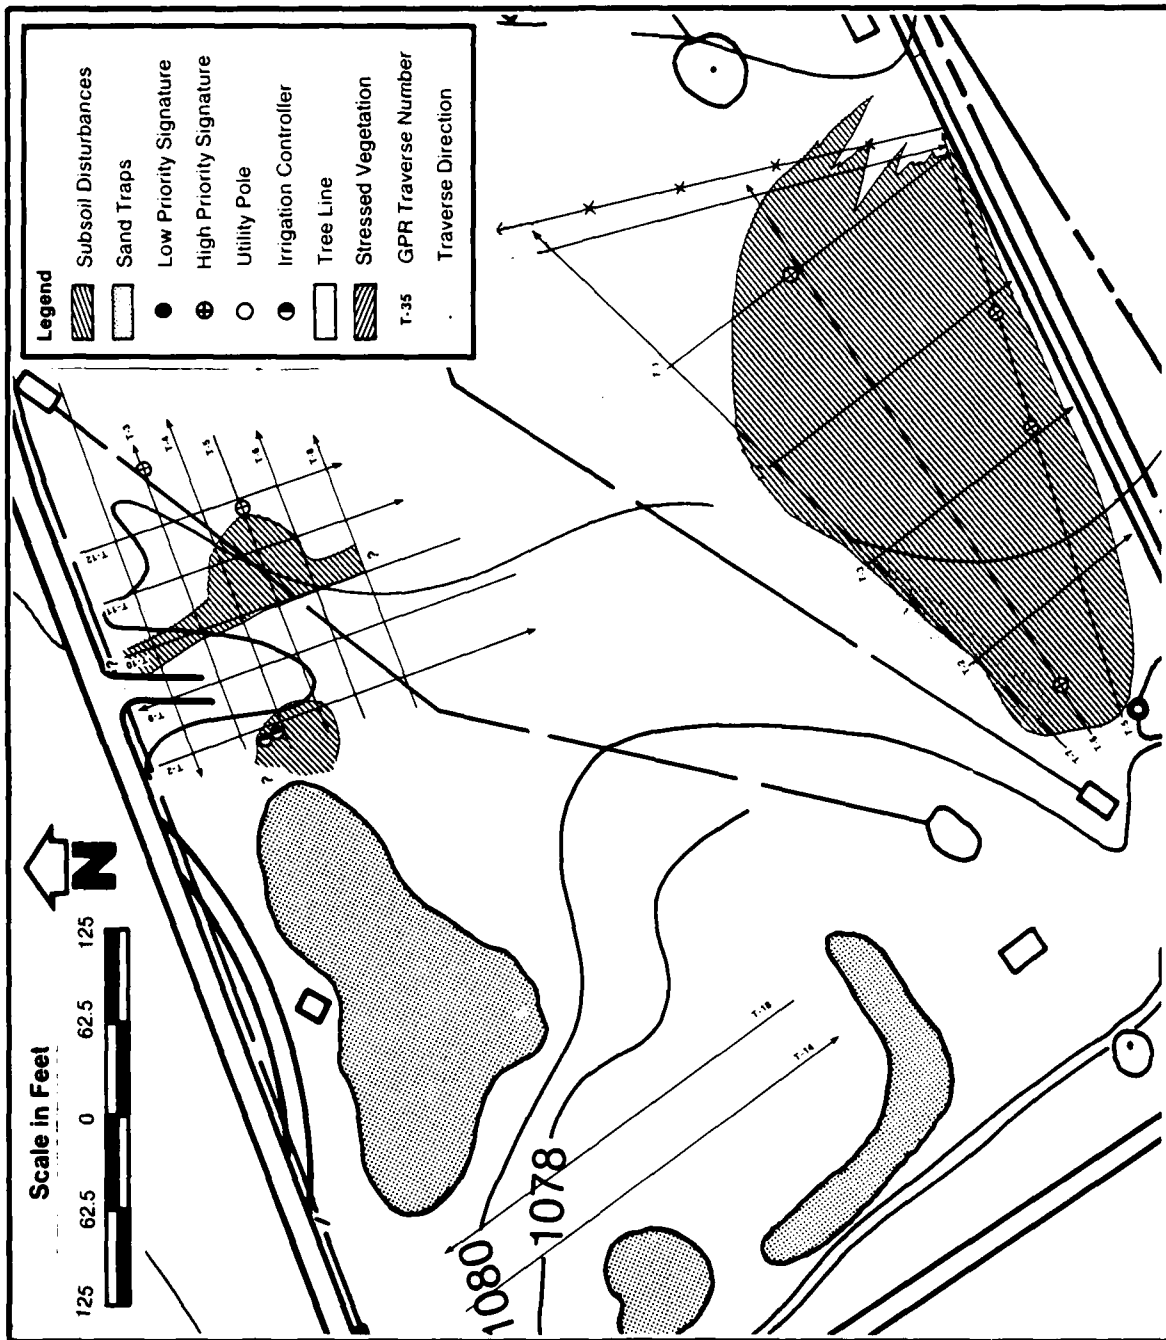
**FIGURE 4-1 ZONE 1, SITES 1, 4 AND 10, INTERPRETATIVE MAP OF
SUBSURFACE CONDITIONS BASED ON GPR SURVEY**

At Site No. 4, a subsurface disturbance was encountered modifying the survey area parallel to traverse 10 (T-10). Based on the GPR profile interface, the configuration of the disturbance boundary, and examination of old aerial photographs, it is suspected that this anomaly is a reflection of an old road bed that crossed the site before it was incorporated into the Golf Course. Another disturbance was detected along traverse 8 (T-8) between traverses 3 and 5 (T-3 and T-5). One high priority target was found in traverse 3 (T-3) east of traverse 12 (T-12). A smaller, low priority target was found on traverse 5 (T-5).

The configuration of the high priority target is similar to that contained in the past from buried drums.

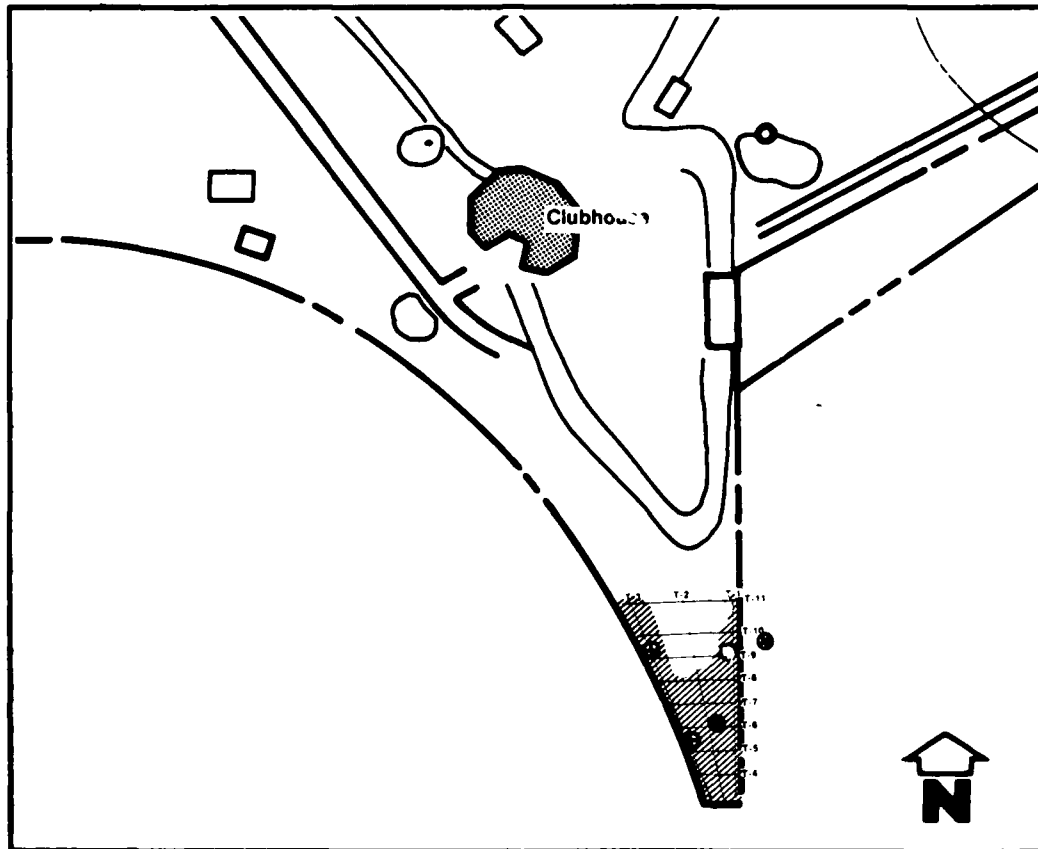
FIGURE 4-2 ZONE 1, SITE 3 INTERPRETATIVE MAP OF SUBSURFACE CONDITIONS BASED ON GPR SURVEY

Only one site was indicated by the GPR survey to require further investigation: Site 3, Waste Pit No. 2, near the Golf Course Parking Lot. Based on the sampling and analyses performed, levels of contamination were found in soils and groundwater warranting further investigation at nine of the fifteen sites investigated, and possible future remedial actions.

1. It is recommended that a magnetometer survey be performed at all sites where high-priority targets were identified in the GPR survey, in order to ascertain whether the targets identified are likely to be metallic (i.e. conductive) drums rather than rock boulders.

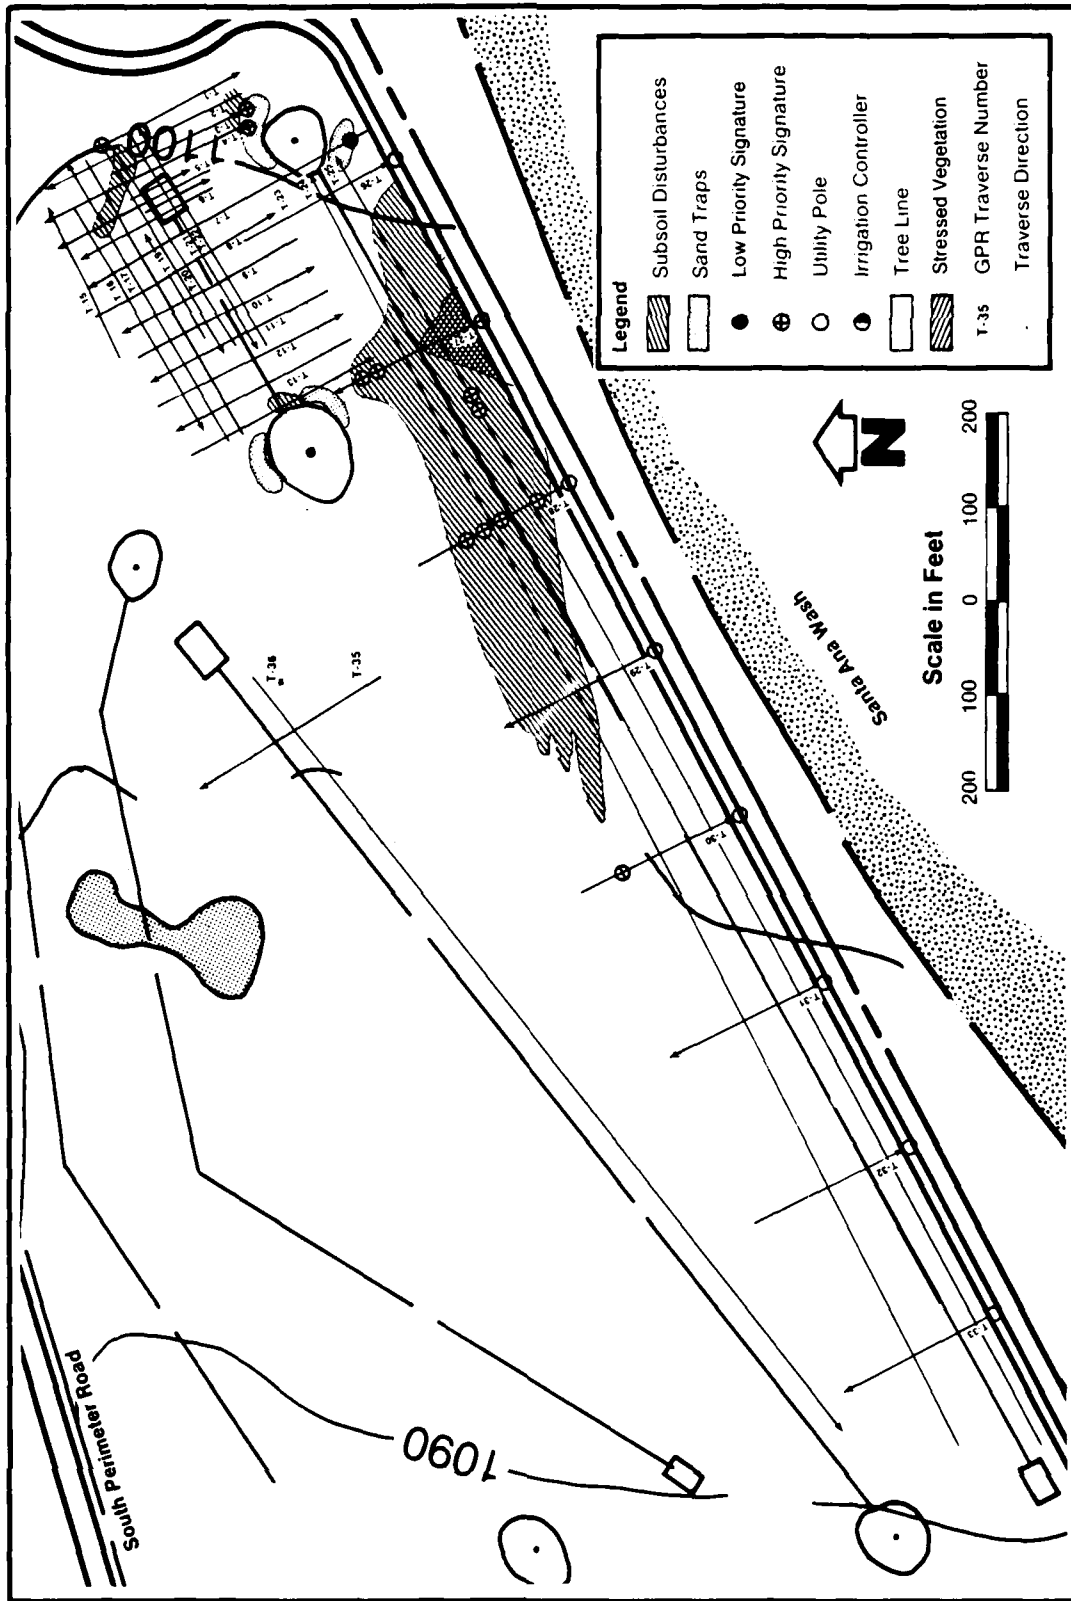
FIGURE 4-3 ZONE 1, SITES 10 AND 12, INTERPRETATIVE MAP OF SUBSURFACE CONDITIONS BASED ON GPR SURVEY

The interpretive maps of the subsurface of Site 10 are depicted in Figures 4-1 and 4-3. Figure 4-1 shows the western portion of the site, and Figure 4-3 represents the central and eastern portions of the site. Two major alterations in the subsoils were encountered in the extreme western and eastern portion of the survey area (Figures 4-1 and 4-3, respectively). Numerous high priority drum-like targets were detected and are plotted on the maps. However, because the GPR detects differences in geometric configuration and conductivities, and sees buried drums and boulders in the same likeness, it is impossible to differentiate between them. Based on the geology of the Santa Ana River Basin and site drilling logs, it is believed that the deeper materials within the two areas are lateral components of the Santa Ana River channel deposits. It is

also suspected that a majority of the high priority targets detected are boulders of the Younger Alluvial deposits.

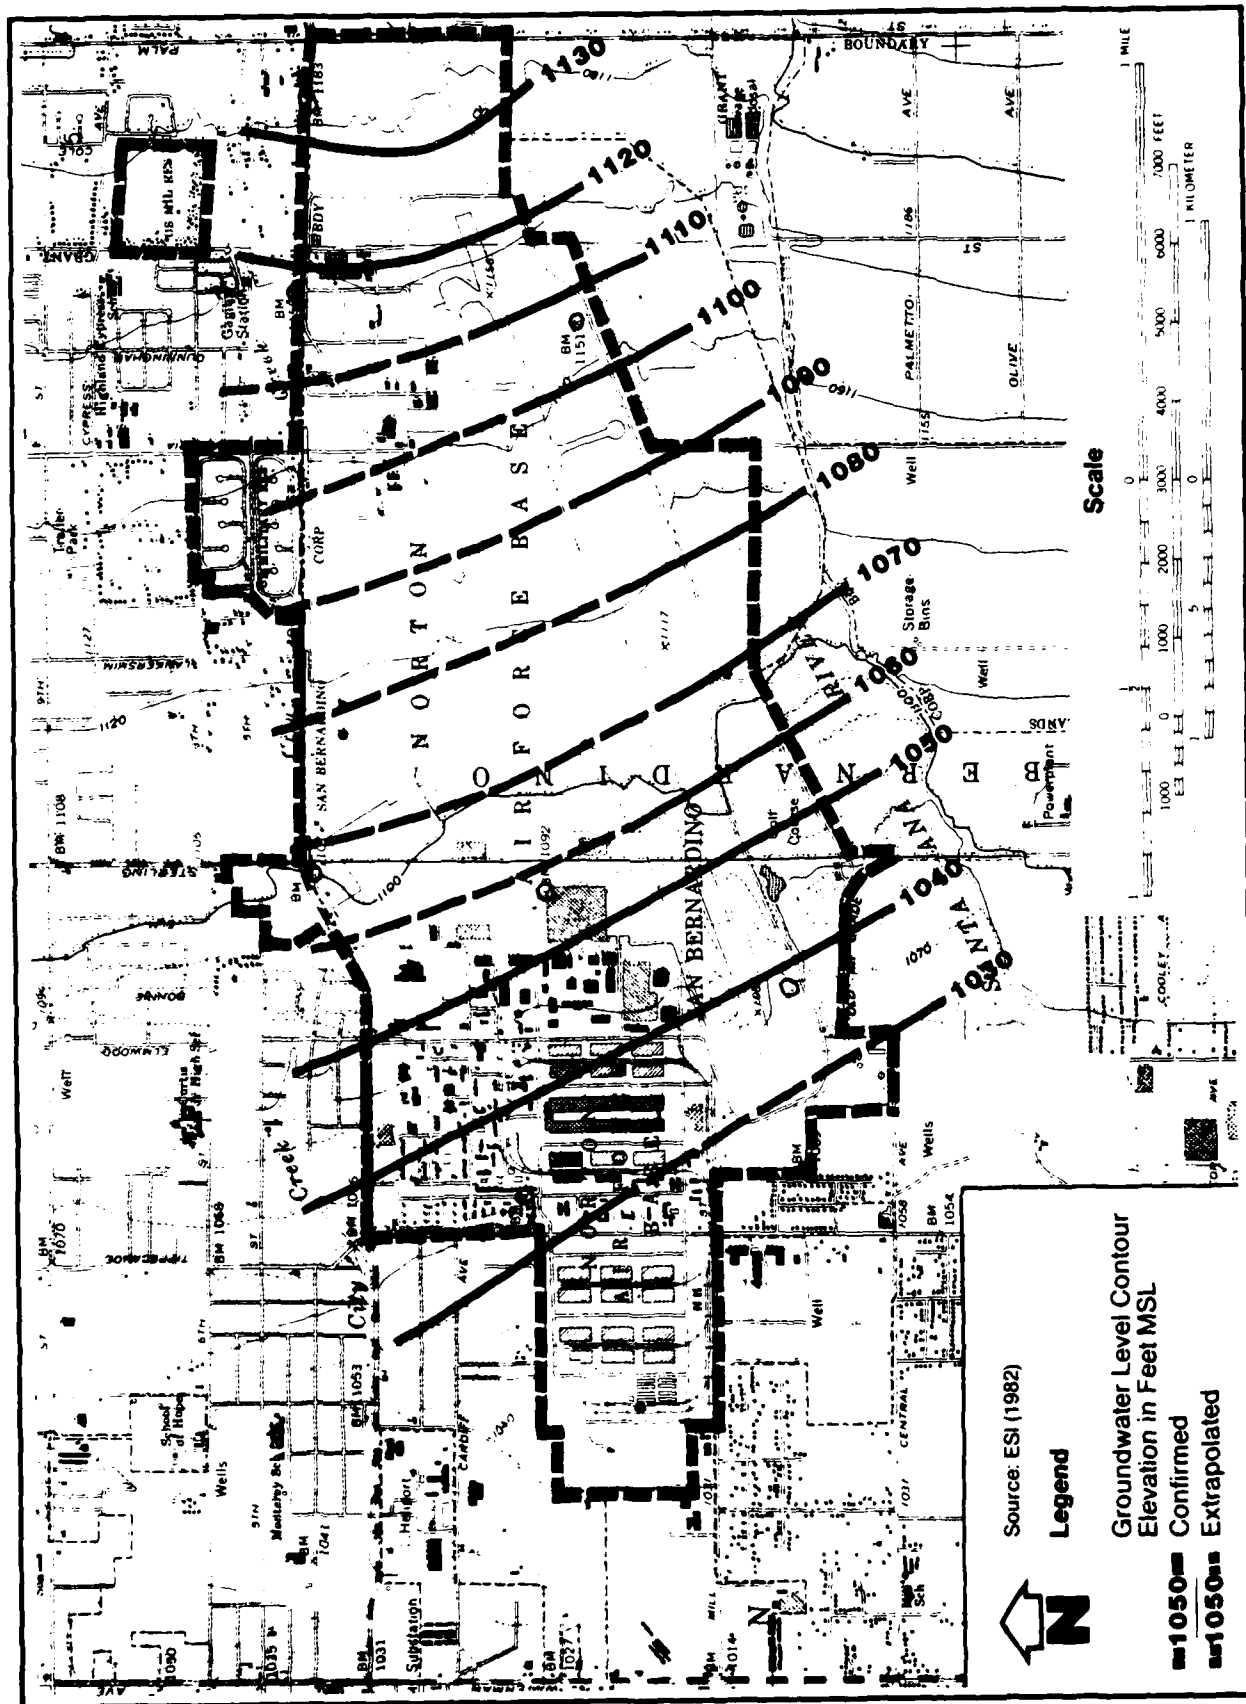
FIGURE 4-4 GENERALIZED GROUND WATER LEVEL MAP OF NORTON AFB

The resulting map (Figure 4-4) indicates that groundwater in the principal aquifer beneath the Base flows downgradient (perpendicular to the contour lines) approximately parallel to the Santa Ana River, in a west-southwesterly direction. Due to the clustered distribution of monitoring wells across the Base, only a very generalized picture could be obtained, and local anomalies related to the effect of pumping wells or other conditions could not be accounted for in the ground water level map. The hydraulic gradient along the southern perimeter appears very uniform, equalling approximately 0.008 beneath both the western end of the Base and the Golf Course, and sloping to the west-southwest. This is approximately parallel to the regional gradient in deeper aquifers as illustrated in Figure 2-5.

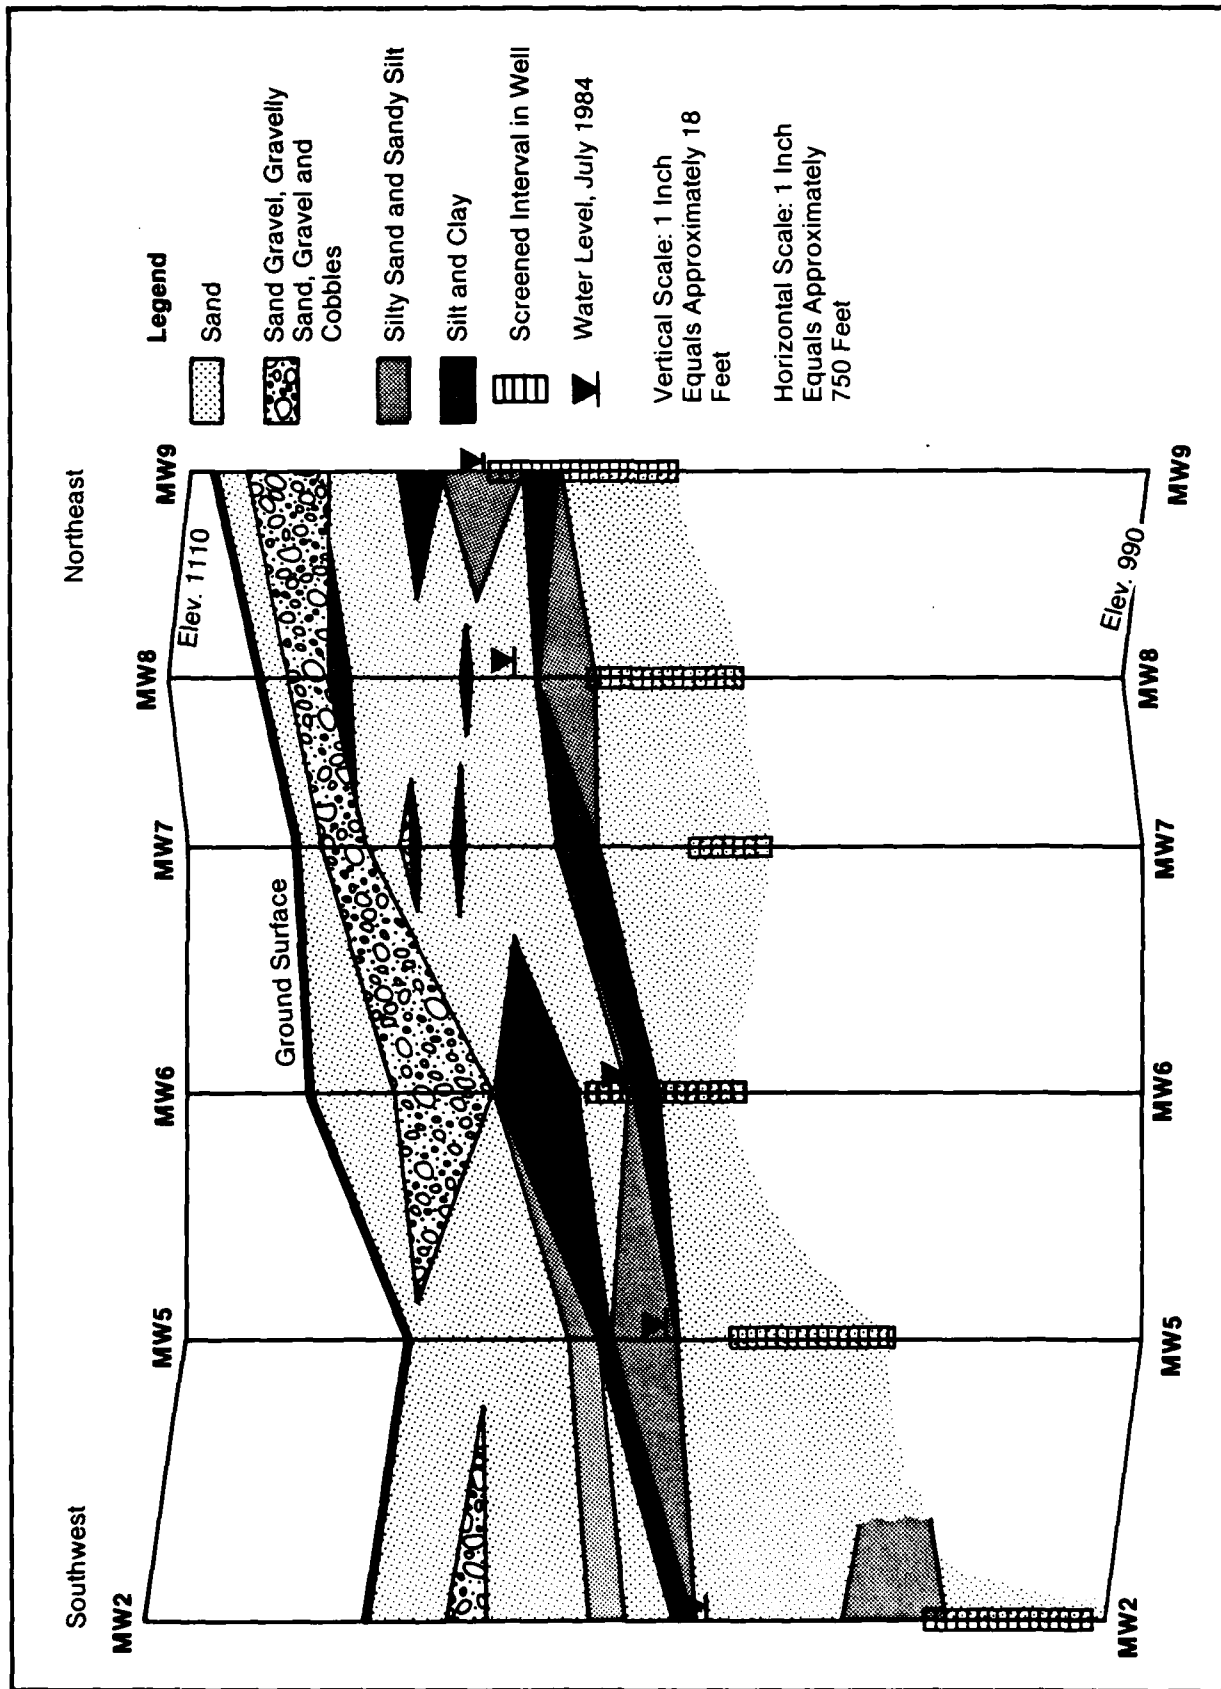
FIGURE 4-6 ZONE 1, GEOLOGIC CROSS-SECTION ALONG SOUTHERN BOUNDARY

in Figure 4-6, indicates clearly that the upper 60 feet of alluvium can be divided into three hydrogeologic strata: an upper sand and gravel layer with localized buried cobble zones from 20 to 40 feet thick; a middle silt and sandy silt zone composed of lenses of silt, sandy silt and silty sand, forming a more-or-less continuous confining layer from 5 to 12 feet thick; and a lower sand layer extending from a depth of 35 to 45 feet below ground surface to at least 60 feet. MW-2, the only well drilled below a depth of 60 feet, penetrated a lower silty sand and sandy silt layer at depths between 58 and 72 feet, and is screened in sand below that layer.

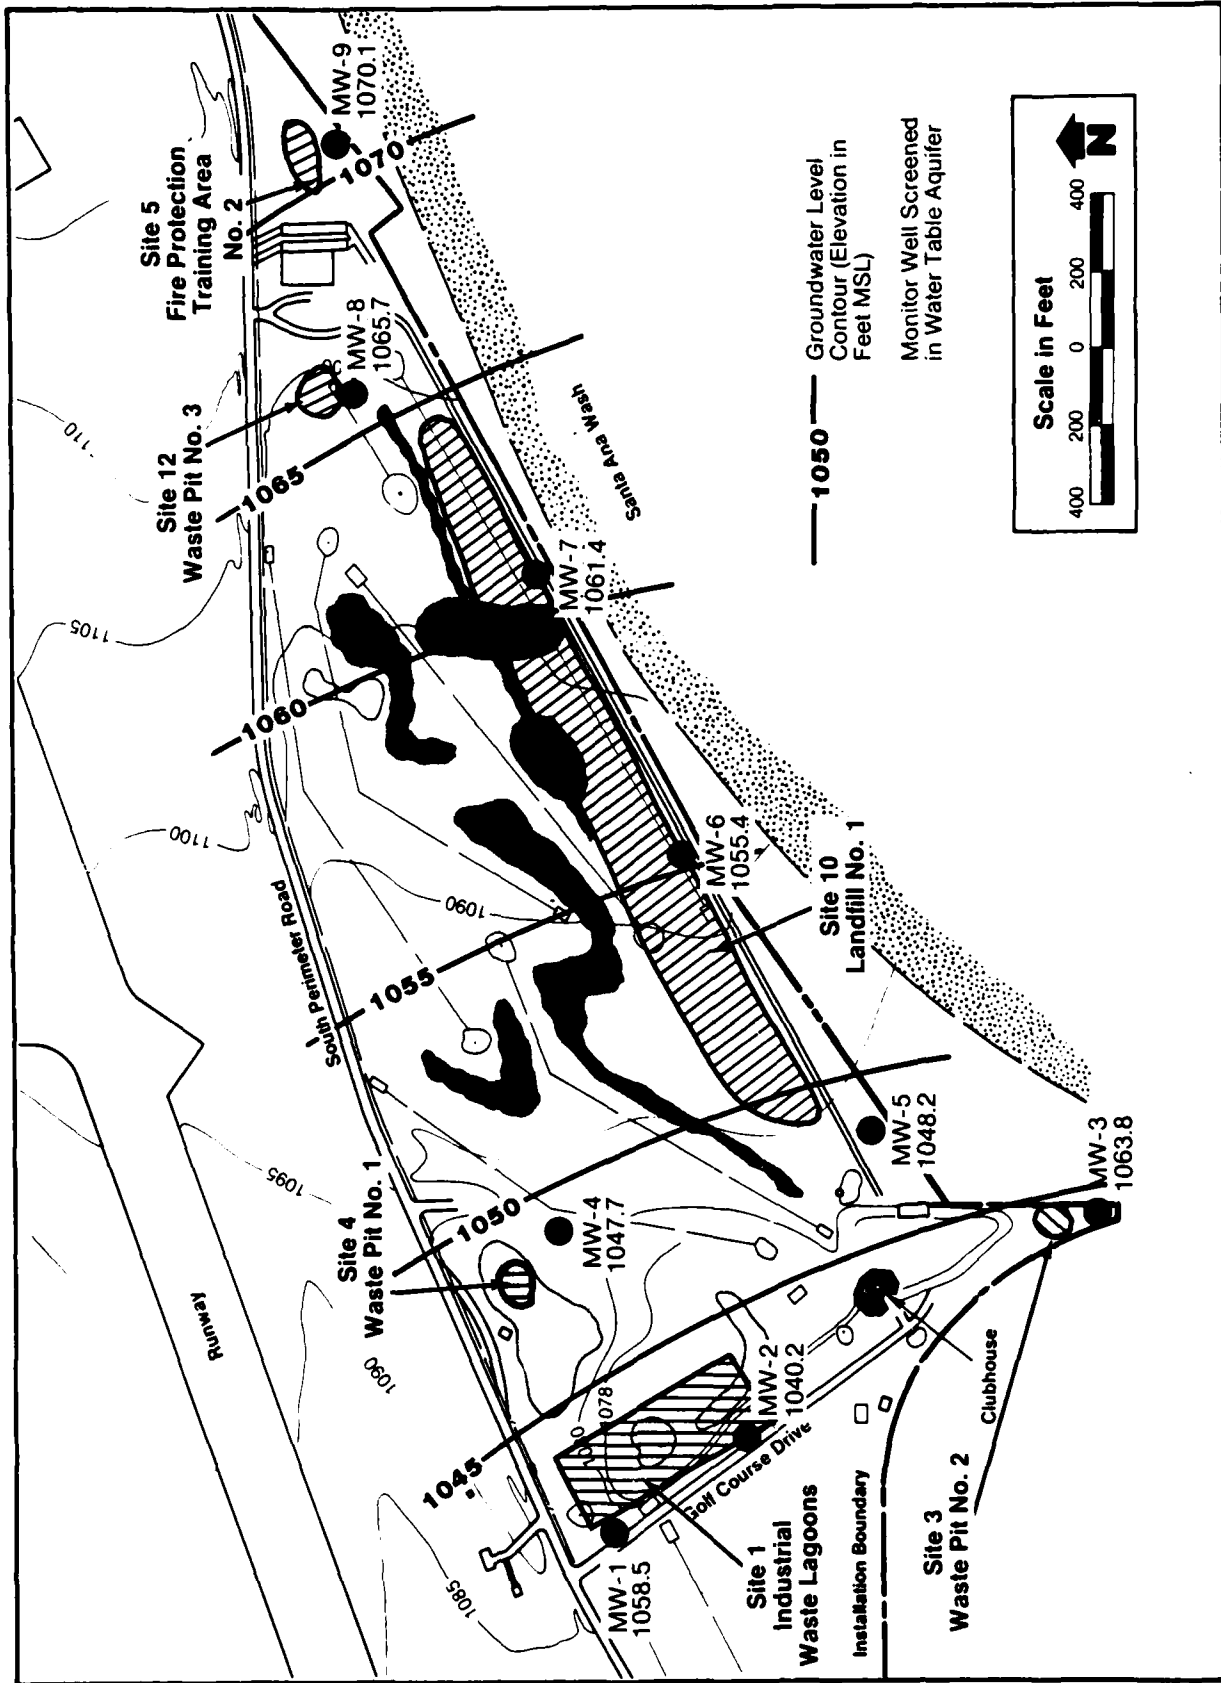
FIGURE 4-7 ZONE 1, GROUND WATER LEVEL MAP FOR PRINCIPAL AQUIFER

The direction of flow in the water table aquifer cannot be accurately determined on the basis of two wells. However, based on the two water levels measured in MW-1 and MW-3 the groundwater gradient would appear to be to the north or

northwest, away from the Santa Ana Wash. Based on the USGS Topographic Quadrangle map, the bottom of the Wash immediately south of MW-3 has an elevation of approximately 1075 feet MSL, or 10 feet higher than the water level measured in MW-3 in July 1984. If there is ground water flow in the shallow water-table aquifer away from the Santa Ana Wash, it may be intermittent and dependent on storm events, or seasonally related. The direction of flow in this Zone may vary considerably over the course of a year. A more extensive network of wells and long-term water level monitoring would be required to more accurately evaluate flow in this Zone.

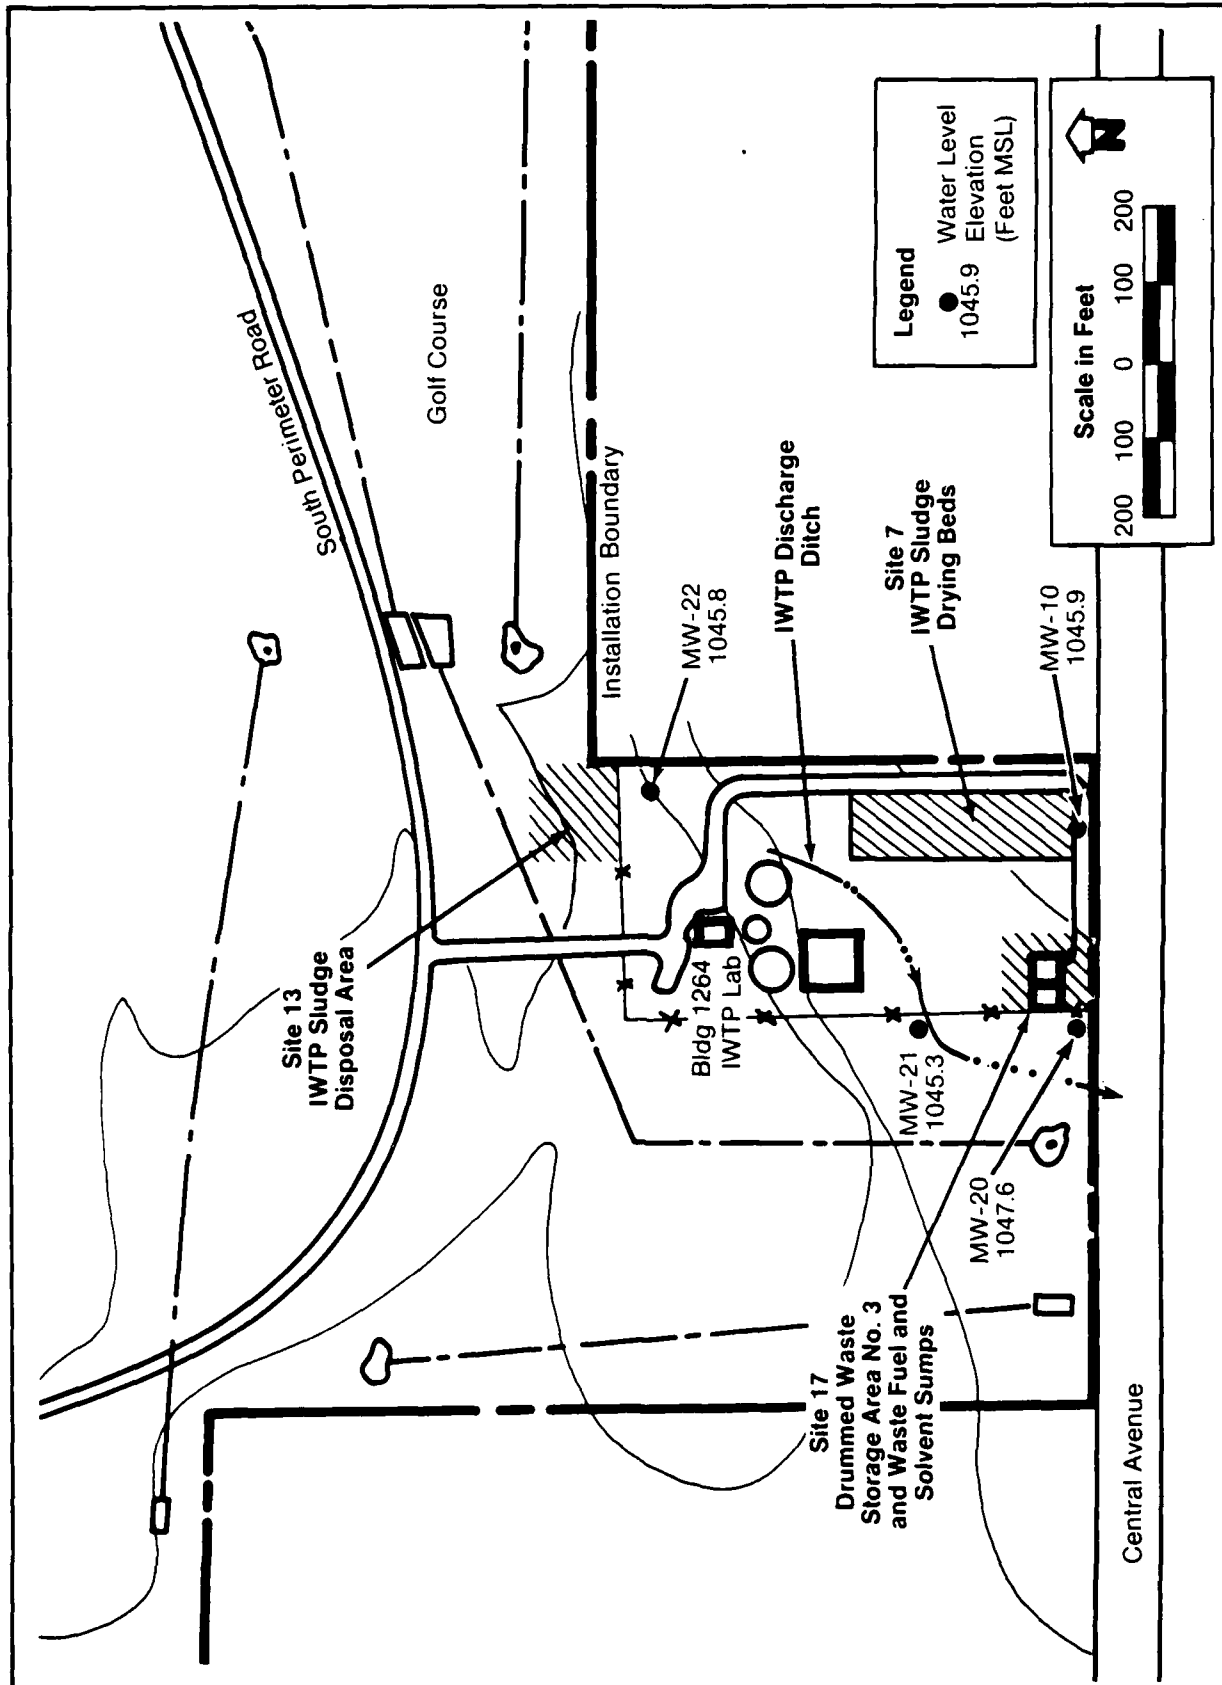
FIGURE 4-9 ZONE 4, GROUND WATER LEVEL ELEVATIONS

The predominant sediment type encountered in all four borings was sand, with little or no gravel. A sandy silt and silty sand layer was encountered in one hole (MW-10) between depths of 9 and 17 feet, and near the bottom of the hole in MW-10 and MW-22. From comparison with well logs and water levels in Zone 1, all four wells are finished in a shallow water-table aquifer overlying and separated from the principal aquifer by a silt layer. Except for MW-20, on the southwestern corner of the compound, the water levels in the wells are very close together (Figure 4-9), and appear to indicate slight hydraulic gradient to the northwest, away from the Santa Ana Wash. This would be consistent with the apparent gradient between MW-1 and MW-3 in Zone 1. MW-20 is located at the bottom of a well-irrigated grassy slope, in a swale. The anomalously high water level measured in MW-20

may be a function of ponding and infiltration of Golf Course irrigation water in the swale within which the well was completed.
